**Flood Control Project Maintenance
Levee Inspections****LMA District Cover Sheet
Spring 2016 Levee Inspection Results****Reclamation District No. 1660 Tisdale**

Levee Inspection Report By Mile - Spring 2016

Reclamation District No. 1660 Tisdale

Waterway	Bank	Unit Miles	Inspection Start/End	Inspector
Unit No. 01 Sacramento River	Left	2.94	03/29/2016 03/29/2016	Keith Millard

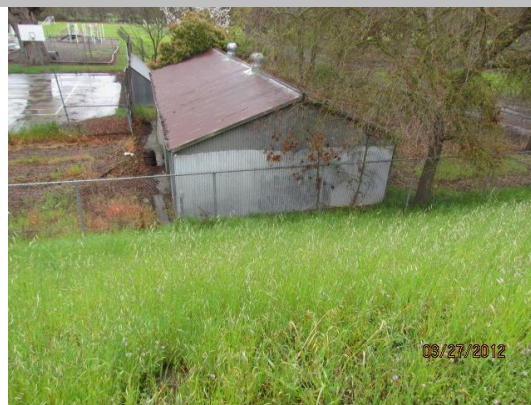
Photo 1 of 1 : SP_2016_RD1660_8_12_20160316_00005.jpg

LM Start	0.05	Rating **	M	Issue No.	12
LM End	0.05	Issue Type +	En	Location *	LS
Category	Earthen Levee			GPS Latitude/Longitude	
				Start	End
Item	Encroachments			39.062643 °	39.062643 °
				-121.837857 °	-121.837857 °
DWR ID	DWR_RD1660_01_s_2012_12				
Comment Code					
BU : Building					
Inspector Comment

View of the building and fence at the landside toe.

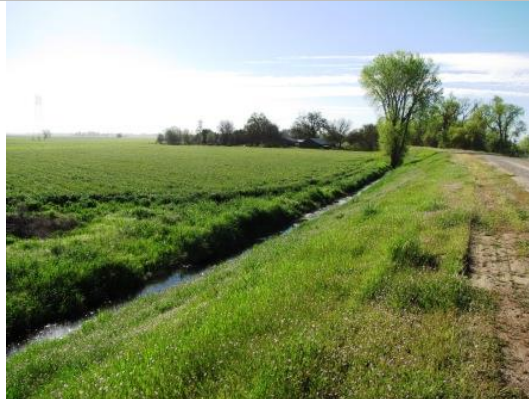
Photo 1 of 1 : SP_2016_RD1660_8_9_20160316_00004.jpg

LM Start	1.10	Rating **	M	Issue No.	9
LM End	1.45	Issue Type +	En	Location *	LS
Category	Earthen Levee			GPS Latitude/Longitude	
				Start	End
Item	Encroachments			39.047610 °	39.043221 °
				-121.838802 °	-121.835815 °
DWR ID	DWR_RD1660_01_s_2012_9				
Comment Code					
DT : Ditch					
Inspector Comment

View of the ag ditch along the L/S toe.

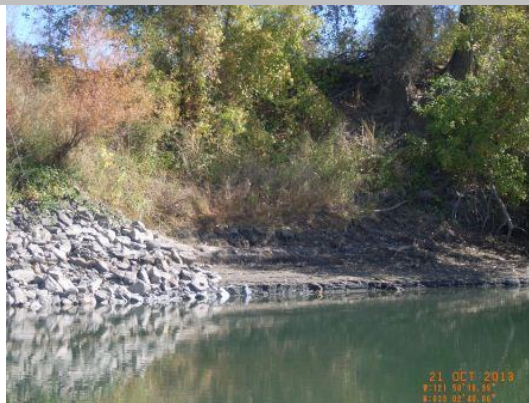
Photo 1 of 1 : SP_2016_RD1660_8_8_20160316_00003.jpg

LM Start	1.33	Rating **	M	Issue No.	8
LM End	1.36	Issue Type +	Ma	Location *	WS
Category	Supplemental			GPS Latitude/Longitude	
				Start	End
Item	2015 USACE Erosion Survey, DRAFT			39.044361 °	39.043916 °
				-121.837654 °	-121.837305 °
DWR ID	DWR_RD1660_01_s_2016_8				
Comment Code					
Inspector Comment					
2009 - Erosion on levee toe where an old cobble site is failing. 2011 - Some new minor erosion. 2012 - Site extended downstream, bank is being impacted from the weight of the trees. 2013 - Minor new erosion at the toe. 2015: Minor new erosion at the toe. [2015 Site ID: SAC_120-6_L]

USACE 2013 Photo #1

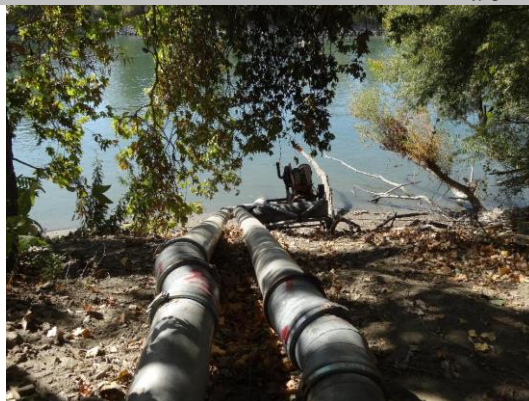
Photo 1 of 2 : UCIP_SP_2016_22543_38142.jpg

Comment Code					
Inspector Comment					
FS_ID:22543 DS_ID:22484 EP_NO: 16476 Repair Type: Non-Urgent Crossing Status: Found UCIP Comments: - 16-inch old steel pipe abandoned. Abandoned pipe found on landside levee toe.- abandoned power pole on waterside.- mobile diesel pump on channel bank.- attached tin pipes exposed on levee surface. FIELD_STRUCT_DESC: 14-inch steel pipe through the levee crown, the placement of two 12-inch diameter tin pipes on the surface of the levee slopes attached to the existing 14-inch steel pipe. The pipe discharges into irrigation ditch on landside. An air vent on landside shoulder. (App. No. 16476 - Ettl, 1997). FS Date: 10/10/2013

WS view: two exposed 12" tin pipes on levee slope. These pipes connected to the pump on river bank.

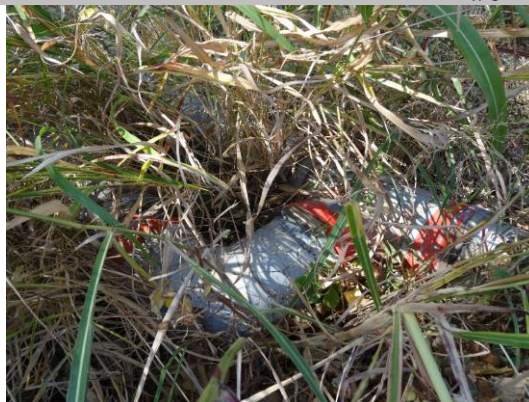
Photo 2 of 2 : UCIP_SP_2016_22543_38141.jpg

WS view: two exposed 12" tin pipes on levee slope.

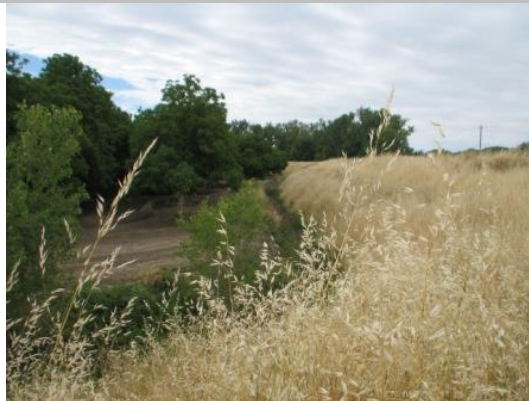
Photo 1 of 1 : SP_2016_RD1660_8_1_20160316_00001.jpg

LM Start	2.01	Rating **	M	Issue No.	1
LM End	2.34	Issue Type +	En	Location *	LS
Category	Earthen Levee			GPS Latitude/Longitude	
				Start	End
Item	Encroachments			39.037640 °	39.034416 °
				-121.828421 °	-121.825698 °
DWR ID	DWR_RD1660_01_s_2012_1				
Comment Code					
DT : Ditch					
Inspector Comment

View of the large ditch along the landside toe.

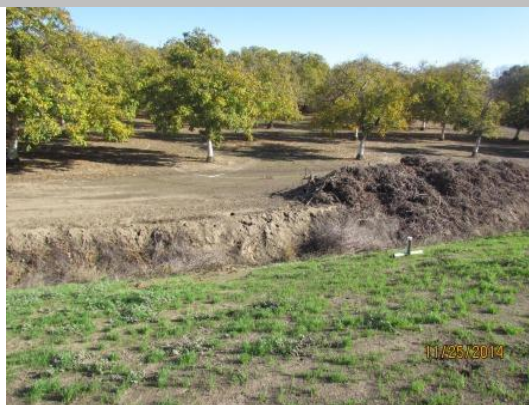
Photo 1 of 1 : SP_2016_RD1660_8_19_20160316_00006.jpg

LM Start	2.16	Rating **	M	Issue No.	19
LM End	2.16	Issue Type +	Ma	Location *	LS
Category	Earthen Levee			GPS Latitude/Longitude	
				Start	End
Item	Animal Control			39.035420 °	39.035420 °
				-121.828530 °	-121.828530 °
DWR ID	DWR_RD1660_01_f_2014_19				
Comment Code					
A3 : No rodents visible, but rodent burrows visible; need to backfill and compact or grout burrows.					
Inspector Comment					
Repair the rodent holes on the landside slope.

View of the rodent holes and bait station.

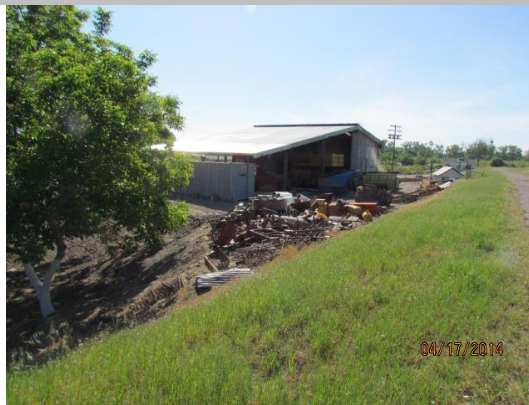
Photo 1 of 1 : SP_2016_RD1660_8_3_20160316_00002.jpg

LM Start	2.58	Rating **	M	Issue No.	3
LM End	2.58	Issue Type +	En	Location *	LS
Category	Earthen Levee			GPS Latitude/Longitude	
				Start	End
Item	Encroachments			39.031405 °	39.031405 °
				-121.823403 °	-121.823403 °
DWR ID	DWR_RD1660_01_s_2012_3				
Comment Code					
EQ : Equipment					
Inspector Comment

View of equipment along the landside slope.

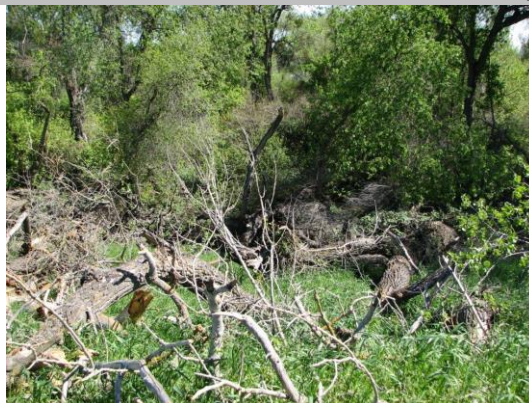
Photo 1 of 1 : SP_2016_RD1660_9_4_20160405_00004.jpg

LM Start	4.53	Rating **	U	Issue No.	4
LM End	4.53	Issue Type +	Ma	Location *	WS
Category	Earthen Levee			GPS Latitude/Longitude	
				Start	End
Item	Vegetation			39.095324 °	39.095324 °
				-121.769581 °	-121.769581 °
DWR ID	DWR_RD1660_02_s_2016_4				
Comment Code					
V7 : Trees / Woody Vegetation					
Inspector Comment					
Remove two large fallen Cottonwood trees on w/s slope from toe to crown.

Downed trees obstructing access

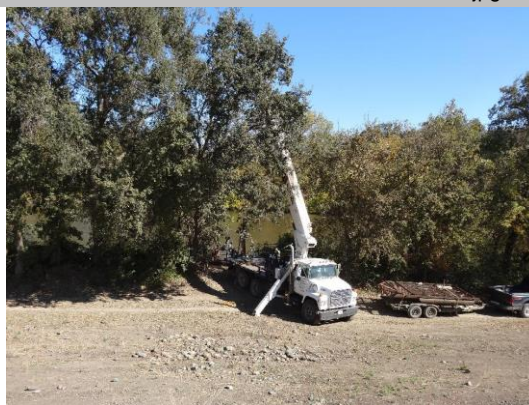
Photo 1 of 2 : UCIP_SP_2016_22705_38394.jpg

LM Start	5.10	Rating **	M	Issue No.	5
LM End	5.10	Issue Type +	En	Location *	WS
Category	Supplemental			GPS Latitude/Longitude	
				Start	End
Item	DWR UCIP Field Study			39.102512 °	39.102512 °
				-121.774960 °	-121.774960 °
DWR ID					
Comment Code					
Inspector Comment					
FS_ID:22705					
DS_ID:22499					
EP_NO: N/A					
Repair Type: Non-Urgent					
Crossing Status: Found					
UCIP Comments: Pressure relief valve on landside levee slope.Pump platform under construction for upgrade (raising platform)Look for new upgrade/revision permit.					
FIELD_STRUCT_DESC: 18-inch steel pipe through the levee, 5.8 feet below crown. Pump in channel. Gate valve on the landward berm. Discharges into 4-foot by 4 foot concrete box on the landward berm. 2-inch electric conduit through the levee, 3.0 feet below the crown.					
(Permit No. 4215, 1963)					
FS Date: 10/15/2013

WS view: pump platform under construction.

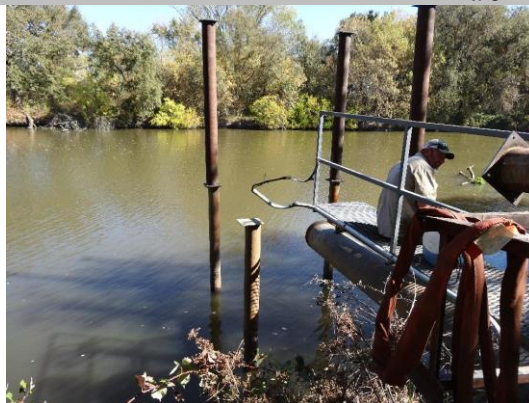
Photo 2 of 2 : UCIP_SP_2016_22705_38393.jpg

LM Start	5.10	Rating **	M	Issue No.	5 (cont)	
LM End	5.10	Issue Type +	En	Location *	WS	
Category	Supplemental			GPS Latitude/Longitude		
				Start		End
Item	DWR UCIP Field Study			39.102512 °		39.102512 °
				-121.774960 °		-121.774960 °
DWR ID						
Comment Code						
Inspector Comment						
FS_ID:22705						
DS_ID:22499						
EP_NO: N/A						
Repair Type: Non-Urgent						
Crossing Status: Found						
UCIP Comments: Pressure relief valve on landside levee slope.Pump platform under construction for upgrade (raising platform)Look for new upgrade/revision permit.						
FIELD_STRUCT_DESC: 18-inch steel pipe through the levee, 5.8 feet below crown. Pump in channel. Gate valve on the landward berm. Discharges into 4-foot by 4 foot concrete box on the landward berm. 2-inch electric conduit through the levee, 3.0 feet below the crown. (Permit No. 4215, 1963)						
FS Date: 10/15/2013

WS view: pump platform under construction. 18" steel pipe and 2" electric conduit under steel platform.
